# Investigation of defects of artificial BSCC heart valves using radiographic computational methods

**Abstract.** Acute mechanical failure of Björk-Shiley convex-concave artificial heart valves has caused thousands of patient deaths over the past decades. This article focuses on the issue of investigating the inhomogeneities whose presence causes progressive heart valve dysfunction and eventual patient death. The results of radiological inspection and subsequent reconstructive methods, based on digital scanning and computed tomography, are presented to detect artefact defects in a series of artificially produced heart valve implants.

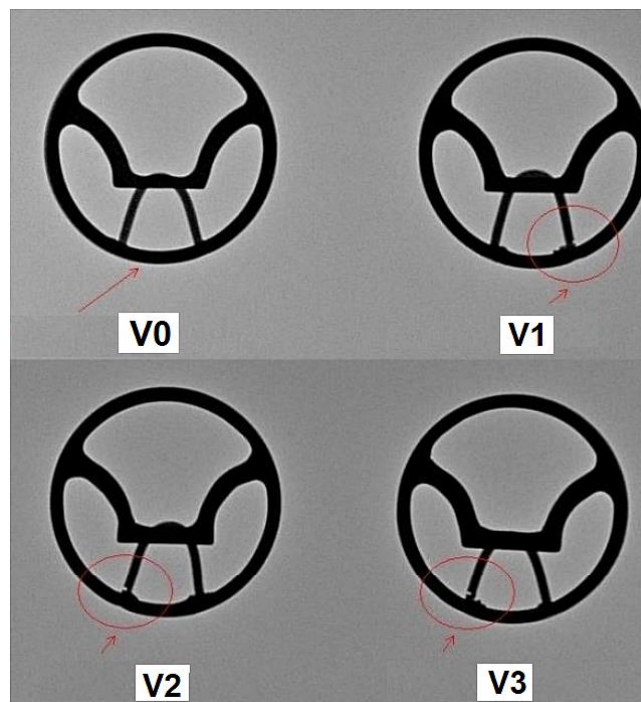
Figure 2 shows the result of imaging the instrument using its exposure automation, with the following

Fig. 2. Overview of the placement and design of artificial defects in the BSCC implant (X-ray image).

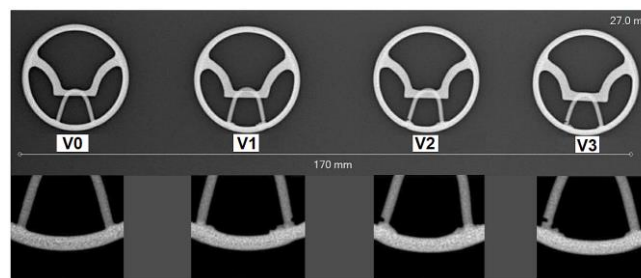
Fig. 3. X-Frame DR2S System results: a comparison of valves with different degrees of damage, with detailed views of outlet struts.

For this purpose, the raw image had to be suitably processed and then significantly enlarged. The measurements of the depth of the inhomogeneities were carried out at an image magnification of 1600%, as shown in Figure 3. The edges and depth of the defects achieve good identifiability due to the high image resolution despite the high magnification level. The resulting dimensions of the inhomogeneities were then stored in the image and checked for the accuracy of the location of the measurement cues at different magnifications. The results of defect depth measurements are summarized in Fig. 4.

Valve No.	Defect depth	Original strut thickness	Percentage of damage
V0	0 mm	1.22 mm	0%
V1	0.34 mm	1.21 mm	28%
V2	0.57 mm	1.22 mm	46%
V	0.68 mm	1.23 mm	55%

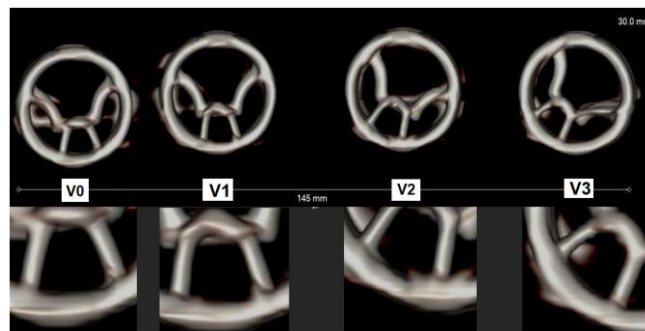
It can be observed that the inhomogeneities formed in the output struts are impossible to identify from the image and thus modified. Therefore, the obtained unadjusted data were adjusted by 3D Slicer and reconstructed as the 3D images. In this reconstruction, preset fixed filters were not used, but the given structures were filtered sequentially, focusing on preserving the maximum information content. The information value of the images in Figures 5 and 6 is significantly negatively affected by the metal artefacts that have formed around the metallic implant structure during the scanning process. During the formation of metal artefacts during CT scanning, we assume that the geometrically minor defects were smoothed out by the reconstruction algorithm due to the presence of metal artefacts in the later reconstruction, causing them to blend in with the surrounding undamaged strut material. For completeness, it should be noted that the type of Optima instrument used was not equipped with software designed for metal artefact reduction (MAR), which is used in the latest computed tomography scanners.

Fig. 5. Overview of reconstructed images created in the GE Healthcare software with detailed views of the output struts.

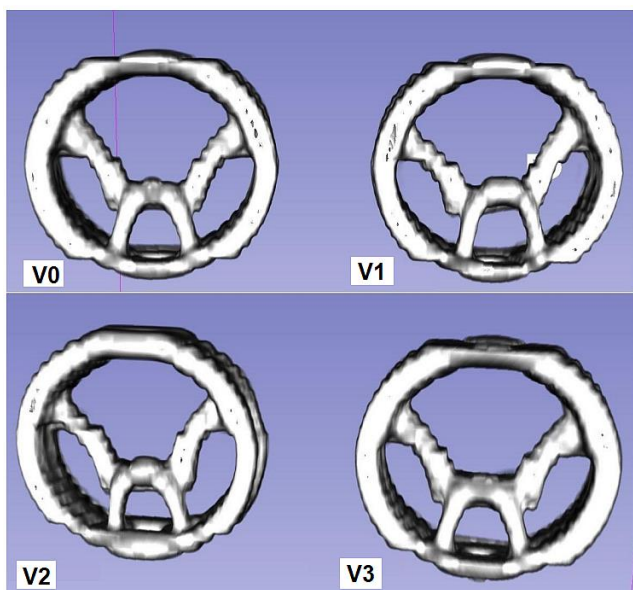
When processing the individual tomographic sections using the RMAR algorithm, small parts of the images representing the flap marginal regions were filtered out in the process of extracting metal artefacts, resulting in 3D reconstructions of the implants with incomplete contours. The editing of individual tomographic sections represents a tedious and time-consuming activity, which, however, could have yielded better results in the identification of cracks in the outlet struts of the valves. For these reasons, we do not consider the RMAR algorithm a suitable tool for editing three-dimensional structures affected by the occurrence of artefacts, as the accumulation of partial errors during the editing of individual sections causes the loss of the information content of the resulting 3D reconstruction. The tomogram processing of the BSCC implants, Fig. 8, did not produce the desired result that could be observed in the case of the digital X-ray images. It can be observed in the

image that the material was narrowing in the attachment of the outlet struts to the rim. On the implants, defects were created in only one part of the exit strut. However, the narrowing of the material can be observed in the image, indicating the presence of inhomogeneities on both sides of the attachment.

Fig. 7. Overview of BSCC implants after filtering metal artefacts in the program wxDicom and subsequent image reconstruction in the Slicer software tool.

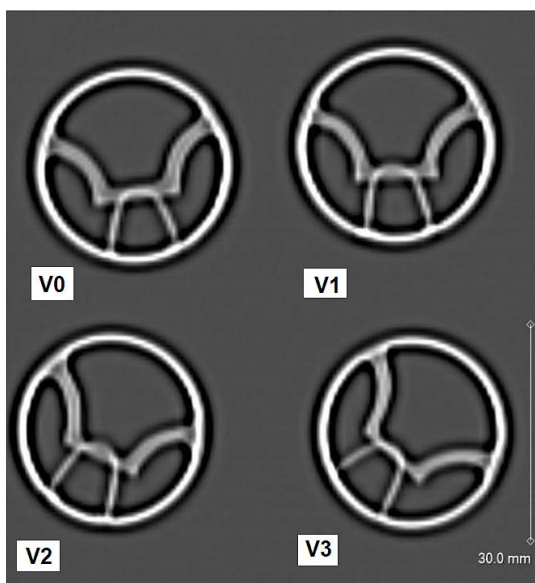
Fig. 8. Tomogram of BSCC implants reconstructed and visualized in the TomoCon software environment.

From the above, the narrowing of the struts cannot be described as a qualitative defect in the implant. We assume that the inhomogeneities in the image are related to the poor quality of the tomographic section.
