Limited Access Inspection of Turbo Generators

Abstract. Limited access inspection (LAI) is the term frequently used to describe inspection of rotating machines without full access to the stator core, i.e. with rotor not removed from the generator. LAI is used as substitute for routine and periodic rotor out inspections on both, hydro and turbo generators, with or without removal of salient rotor poles. In recent years, due to de-regulation of the industry and newer designs of high speed turbogenerators with very long major overhaul intervals, there was an increase in requirements for this type of testing. The most frequent tests performed are stator core interlaminar insulation testing (EL CID), stator wedge tightness inspection and visual inspection of stator and rotor. LAI has reduced extensive downtime due to rotor removal and assembly versus performing a conventional inspection and reduced risks associated with rotor removal and insertion.

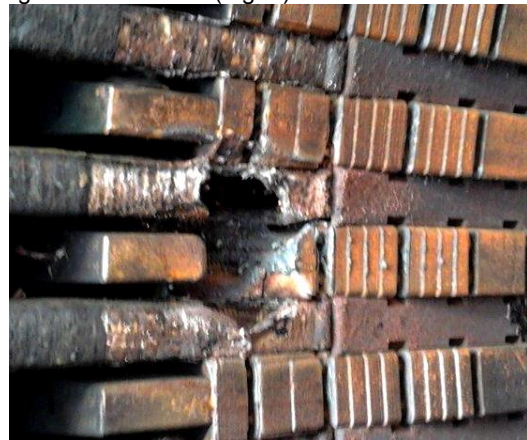
Fig. 2 Melted stator step iron due to very high temperature (high value of circulating current)

Circulating currents in combination with overheating can cause propagation of the fault. In final stage stator core can melt or due to high temperature main insulation of the stator winding can break down (Fig. 2).

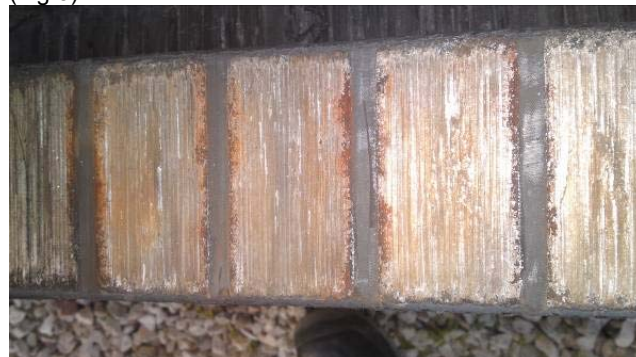
Fig. 5. Damage of stator bar outer corona protection due to bar vibration.

The mechanism is sometimes referred to as slot discharge, because once the semiconductive coating is abraded, partial discharges occur between the coil surface and the core, further increasing the rate of deterioration (Fig.5)

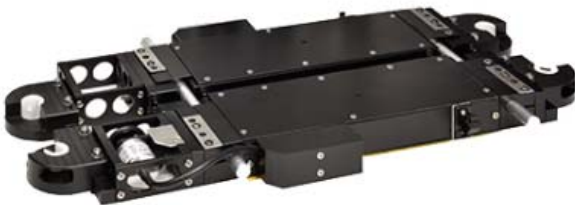
Fig. 6. Low profile Robotic Vehicle

The Robotic Inspection Vehicle (RIV) and accessories Fig. 6, allows remote and robotic testing to be achieved. The vehicle is attached magnetically to the stator teeth, and guides itself along each slot using magnetic sensors, to achieve and maintain correct alignment. The RIV is of particular value when there is only limited access in a small stator, or when a large amount of testing requires automation to reduce the labor involved (e.g. large hydrogenerators).

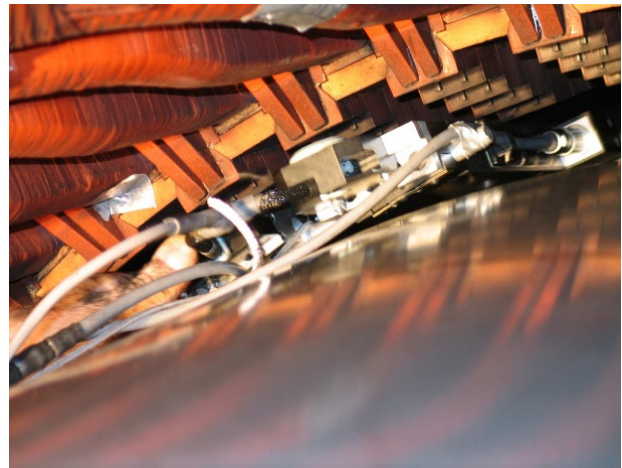
Fig. 8. RIV entering air-gap (150MW)

The greatest gain however comes in allowing tests to be performed with the rotor still in place, where the RIV can be run inside the rotor-stator air-gap. Fig. 7 and 8 show RIV being launched into air-gaps in typical situations on two different turbo generators.

This test method is usually restricted to larger turbo-generators from about 100MW upwards, depending on access past the rotor end rings. In hydro-generators the air-gap is usually too small, but the gap between the poles can be exploited, possibly with a pole removed, then the rotor turned to allow testing of the whole core. There is no direct link between MW rating of the machine and size of the entrance/air gap, so larger the machine does not mean that the entrance gap is larger. However, it seems that older machines do provide larger entrance gaps, compared to newer machines of the similar rating.

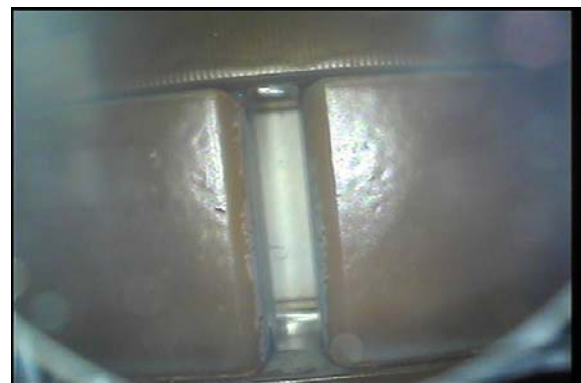
Fig. 10. Sample of visual inspection during LAI – movements in rotor wedges

One of the additional devices which can be mounted on RIV is high resolution video camera which allow to perform visual inspection during runs. Camera is mounted in front of the RIV, and can be rotated in two planes. This allows to observe stator core surface, stator and rotor slot wedges, rotor surface and stator and rotor air ducts.

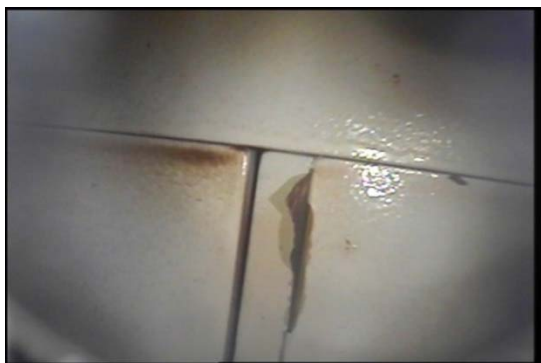
Fig. 11. Cracks of paint on rotor wedge - probably loose wedge

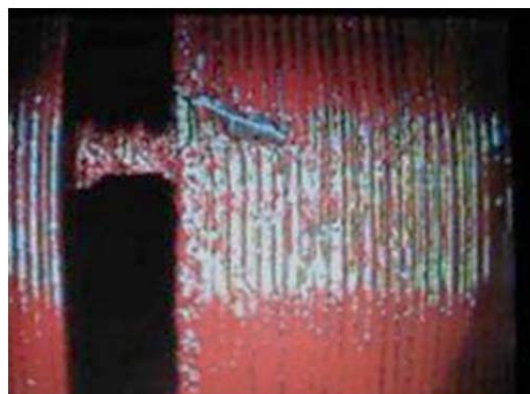
Fig. 14. Stator Core Damage as Seen with ELCID / Robotic Inspection Vehicle Camera

Visual evidence of possible core damage was photographed and the inspection vehicle was used to move the Chattock sensing coil of the Iris Power EL CID along stator core to test the damaged area. The information obtained indicated that the damage was not sufficient to warrant removing the rotor.[3]

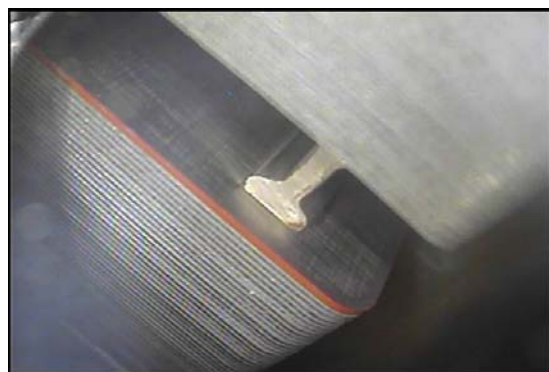
Fig. 15. Clean surface of air duct in middle part of the core

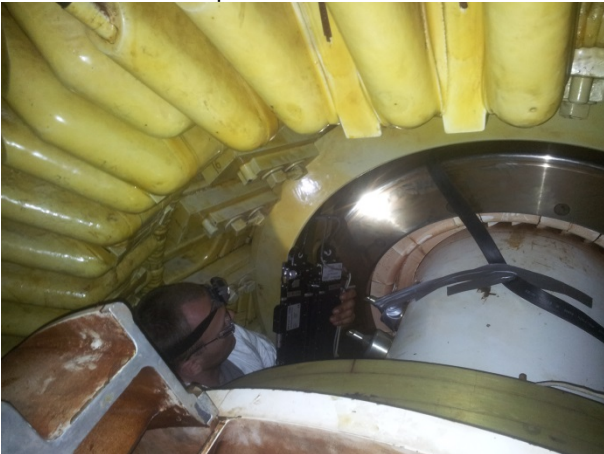
Fig. 17. LAI on full closed generator BBC 425 MW.

In some type of generators, LAI can be done without major disassembly of generator end covers, seals etc. To place the robot inside the air gap, it might be possible to use inspection holes after removal of covers and/or rotor fan blades inside generator frame. Possibility to perform LAI on full closed generators are usually restricted to older generators with rated power over 300 MW.
