# Investigation of defects of artificial BSCC heart valves using radiographic computational methods

**Abstract.** Acute mechanical failure of Björk-Shiley convex-concave artificial heart valves has caused thousands of patient deaths over the past decades. This article focuses on the issue of investigating the inhomogeneities whose presence causes progressive heart valve dysfunction and eventual patient death. The results of radiological inspection and subsequent reconstructive methods, based on digital scanning and computed tomography, are presented to detect artefact defects in a series of artificially produced heart valve implants.

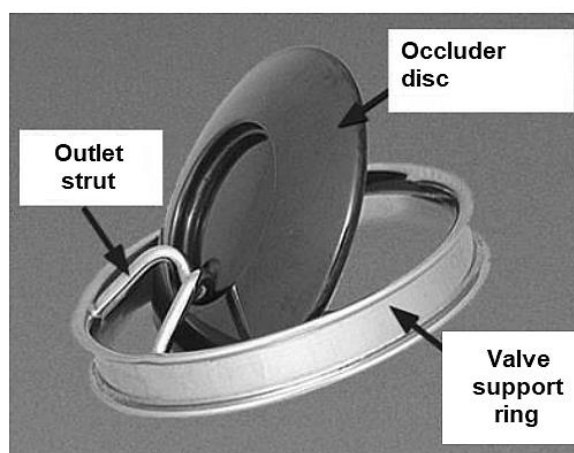
One of the design improvements was to weld the BSCC valve outlet strut at an angle that was not parallel to the flange. As a result of this modification, the tension at the strut joint was increased. Moreover, the flange fractured the structure above and caused the patient's sudden cardiac death. For the reasons mentioned above, the complication rate induced by the strut failure was further increased when the disc opening angle was increased from the original 60° to 70° (Fig. 1).

Fig.1. BSCC heart valve implant: basic functional design, [5].

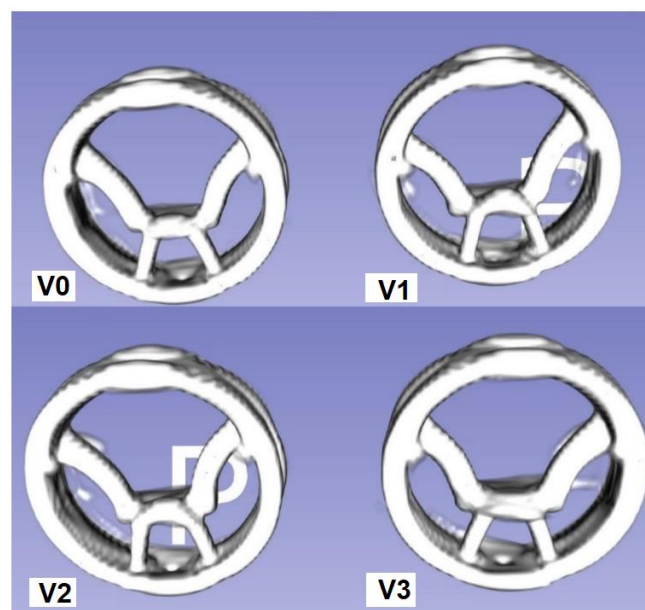
It can be observed that the inhomogeneities formed in the output struts are impossible to identify from the image and thus modified. Therefore, the obtained unadjusted data were adjusted by 3D Slicer and reconstructed as the 3D images. In this reconstruction, preset fixed filters were not used, but the given structures were filtered sequentially, focusing on preserving the maximum information content. The information value of the images in Figures 5 and 6 is significantly negatively affected by the metal artefacts that have formed around the metallic implant structure during the scanning process. During the formation of metal artefacts during CT scanning, we assume that the geometrically minor defects were smoothed out by the reconstruction algorithm due to the presence of metal artefacts in the later reconstruction, causing them to blend in with the surrounding undamaged strut material. For completeness, it should be noted that the type of Optima instrument used was not equipped with software designed for metal artefact reduction (MAR), which is used in the latest computed tomography scanners.

Fig. 6. 3D reconstruction of BSCC implants in Slicer software tool.

When processing the individual tomographic sections using the RMAR algorithm, small parts of the images representing the flap marginal regions were filtered out in the process of extracting metal artefacts, resulting in 3D reconstructions of the implants with incomplete contours. The editing of individual tomographic sections represents a tedious and time-consuming activity, which, however, could have yielded better results in the identification of cracks in the outlet struts of the valves. For these reasons, we do not consider the RMAR algorithm a suitable tool for editing three-dimensional structures affected by the occurrence of artefacts, as the accumulation of partial errors during the editing of individual sections causes the loss of the information content of the resulting 3D reconstruction. The tomogram processing of the BSCC implants, Fig. 8, did not produce the desired result that could be observed in the case of the digital X-ray images. It can be observed in the
